Landfill mining in practice: Dismantling of the old dump Kössen / Austria

Martin Steiner

TBU Environmental Engineering Consultants, Innsbruck (Austria)

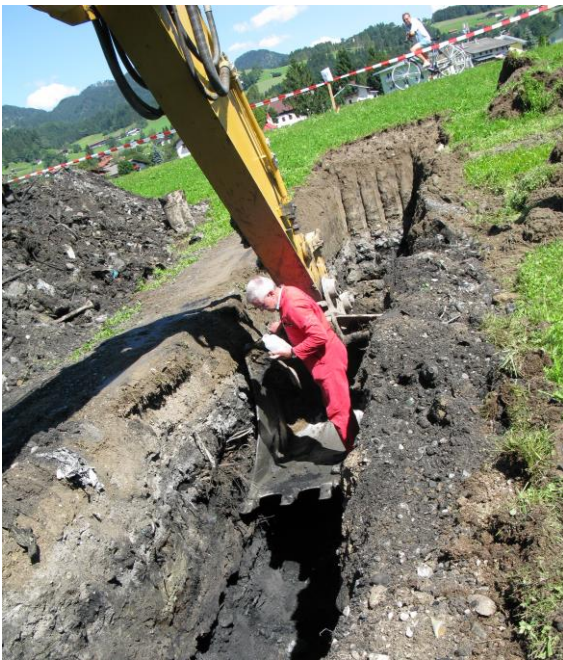
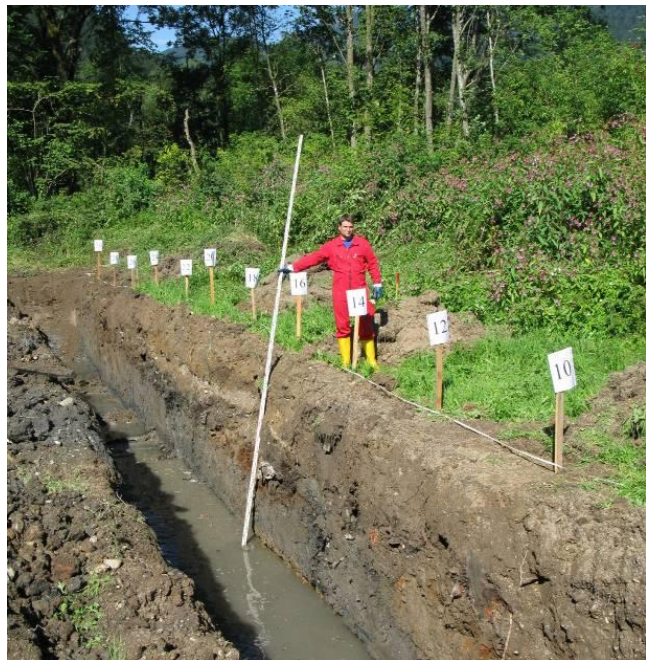
Figure 1 Digging of trenches with sampling (left photo) in order to receive an overview on contaminants as well as volume proportions by documenting measures of single layers

- *the evaluation of historical data* (which turned out as relatively fruitful compared to similar cases)
- *interviews* with former operating staff and finally
- *the digging of trenches* – total length about 800 m, distance between trenches 10 and 15 m – on the entire surface down to the landfill body's bottom.

The achieved data gave a good picture on the landfill's composition which provides not only an indication about expectable disposal cost, but also on the way subsequent excavation works have to be organized. As a particular question the one on the date of final landfill closure (which in such cases often matters in legal terms – who will bear which cost ?) could be answered by finding certain items which allow a clear judgement on its earliest disposal = latest closure date (eg. food and beverage packaging with readable shelf dates, refer to Figure 2).

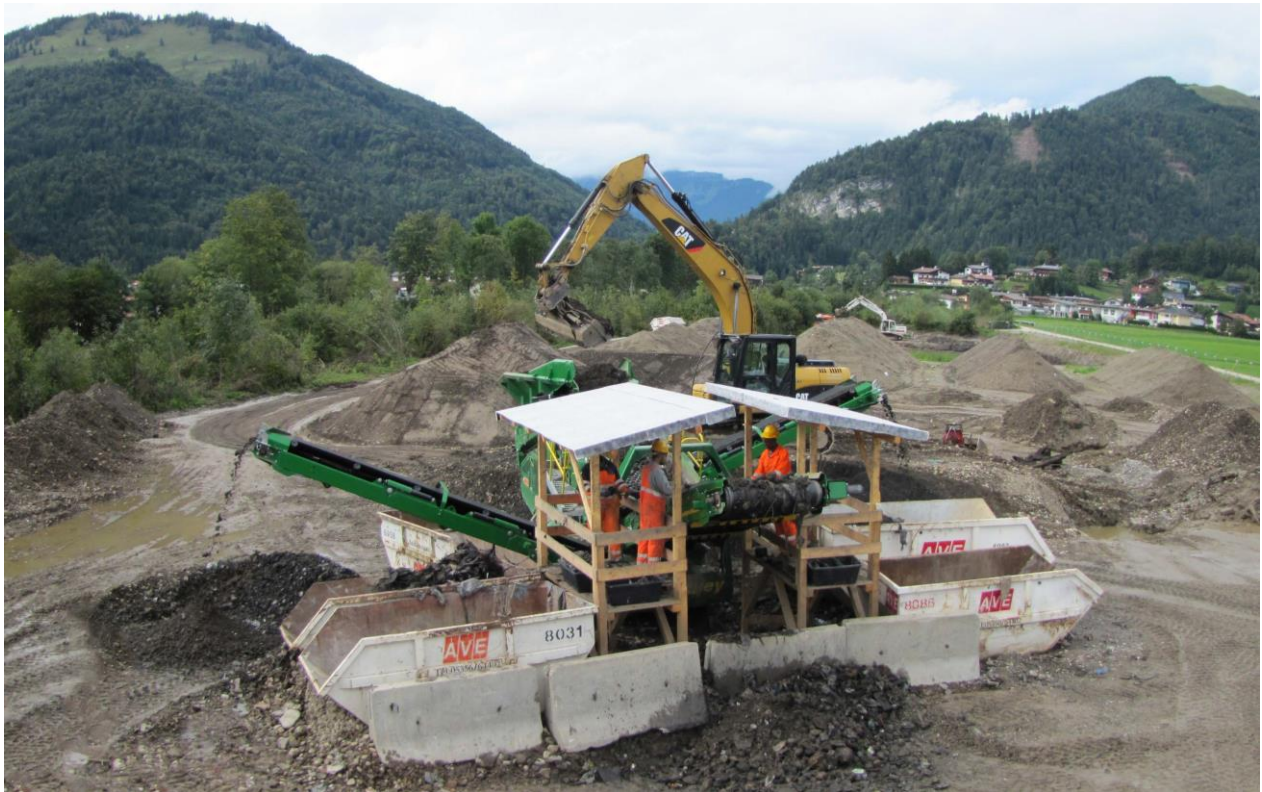
Figure 4 Core unit applied for dismantling the dump's inventory: a vibration screen producing a fine fraction (leaving the screen right hand side, windrows visible in background), a fraction 40 ... 70 mm (left) for further processing via air classifier, and > 70 mm out of which the fractions wood, glass, scrap metal and plastics/MSW are sorted manually.

For a flow sheet of the applied separation process it is referred to Figure 3; the core unit – a vibration screen with two mesh sizes, 40 and 70 mm and manual sorting of its overflow – is shown below.
